Home Inspection Report

Be Informed

Home Inspections, LLC

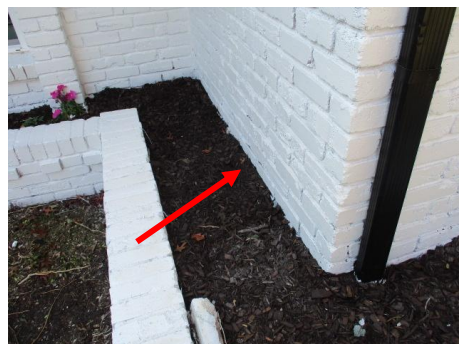
The raised flowerbeds at the front of the home are blocking the ventilation for the crawlspace. Ventilation of the crawl space is insufficient. One (1) square foot of free vent area should be provided for every five hundred (500) square feet of crawl space. Proper ventilation will help to control humidity and reduce the potential for rot. Crawl spaces can be vented to the building interior or exterior, depending on the configuration of the crawl space.

Figure 1 Example of high soil/blocked crawlspace ventilation at front flowerbeds

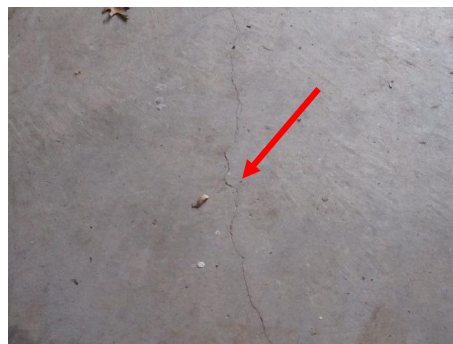
Minor cracking was observed in the foundation at the surface of the garage floor. This type of cracking is usually the result of shrinkage of the concrete as it cures. Shrinkage cracks are very common and should not be cause for alarm. (Figure 2)

Figure 2 Example of shrinkage cracking at garage floor

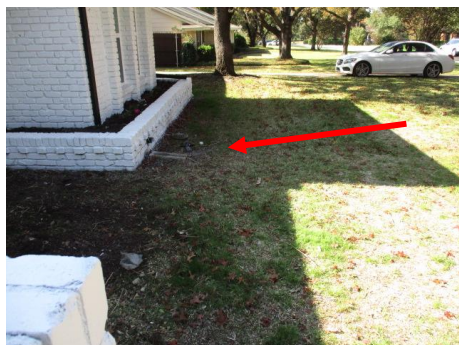
A flat grade was observed at the front and rear of the home. The grading should be improved to promote the flow of storm water away from the house. This can usually be accomplished by the addition of top soil. The ground should slope away from the house at a rate of one inch per foot for at least the first ten feet. Ideally, at least eight (8) inches of clearance should be maintained between soil level and the top of the foundation walls. (Figures 1-3)

Figure 1 Example of flat grade at front of home

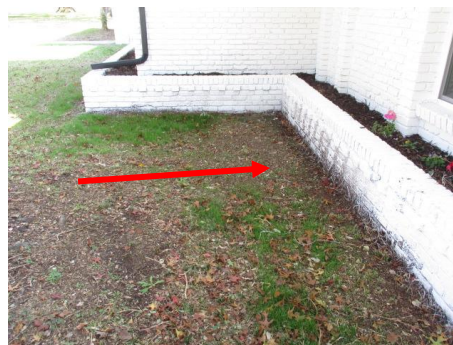
Figure 2 Example of negative grade against front flower beds

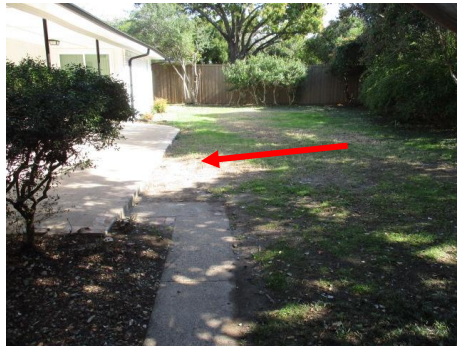
Figure 3 Example of flat grade at rear of home

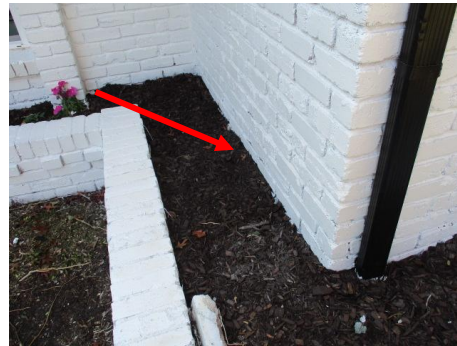
High soil observed at the front of the home in the flower beds. The top of the foundation should be a minimum of six inches above earth. This will help protect against WDI (wood destroying insects) and moisture. (Figure 4)

Figure 4 Example of high soil at front flower beds

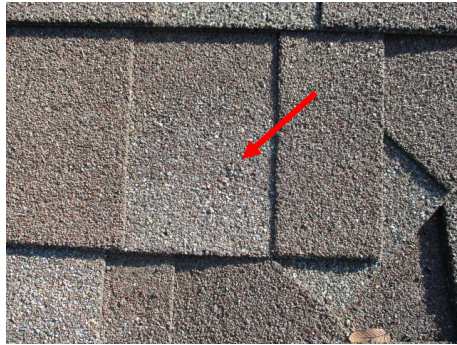
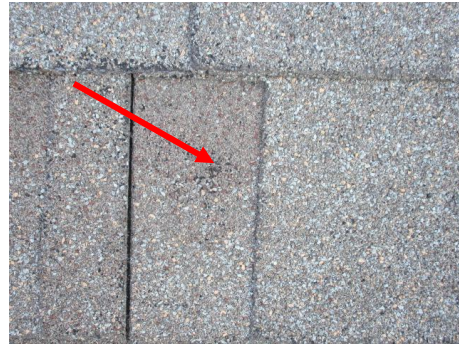
The roof is considered to be in fair condition. The roof is showing wear, and the deterioration will be increased due to the bruising. The bruising on the roof appears to be hail damage and client should check with the homeowner's insurance concerning filing a claim related to this damage.

Figure 1 Example of hail damage

Figure 2 Example of hail damage

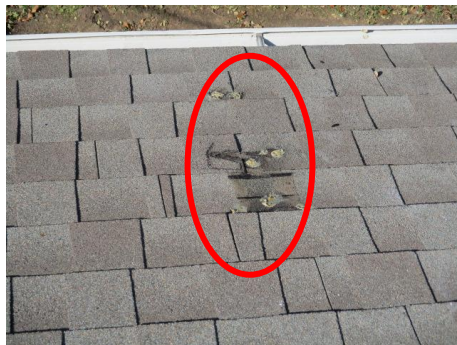
Missing shingles were noted at the southwest corner of the roof due to relocation of the satellite mounting bracket and should be installed.

Figure 3 Example of missing shingles

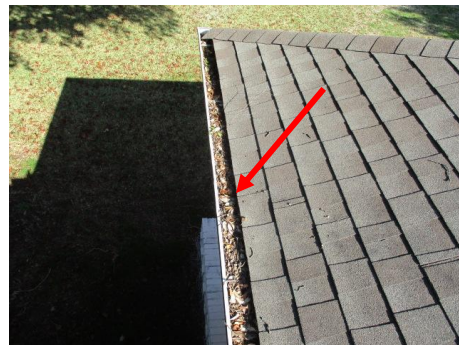
The gutters require cleaning to avoid spilling roof runoff around the building – a potential source of water entry or water damage.

Figure 4 Example of clogged gutters

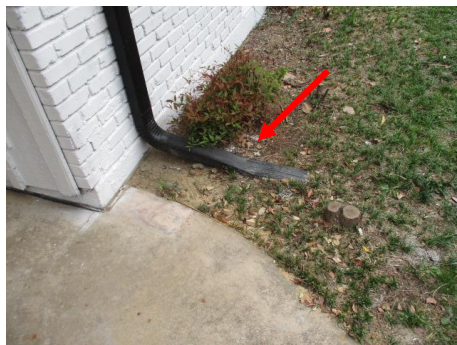
Figure 5 Example of damaged gutters

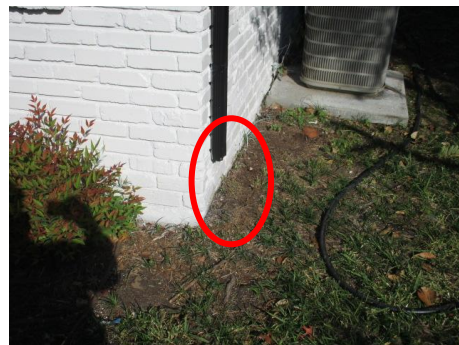
Loose, missing, or damaged downspouts should be repaired promptly.

Figure 6 Example of missing downspout

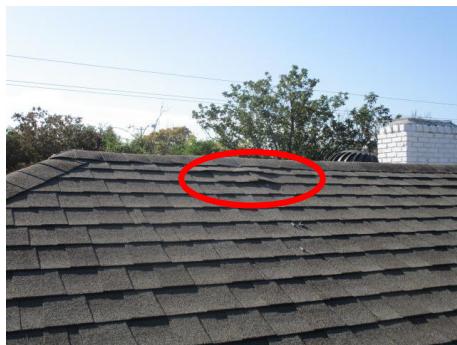
Raised shingles were noted at the front side of the east slope and should be better secured and sealed to prevent damage from leaks.

Figure 7 Example of raised shingles

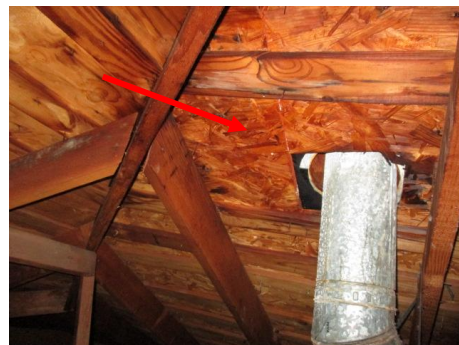
A roof leak was noted adjacent to the furnace gas flue. This was evidenced by staining and moisture at the roof sheathing in the attic. The area should be investigated further and repaired to prevent further damage.

Figure 8 Example of roof leak adjacent to furnace gas flue

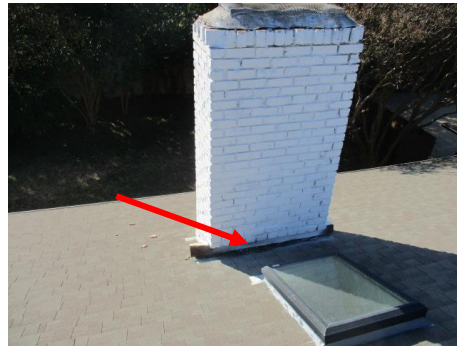
A missing cricket was noted for the chimney and should be installed to prevent the buildup of debris and possible damage from leaks.

Figure 9 Example of missing chimney cricket

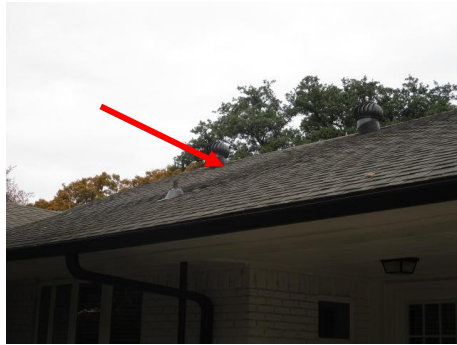
Figure 1 Example of ridge sag at south roof slope

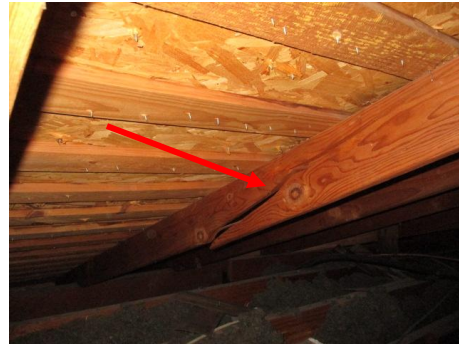
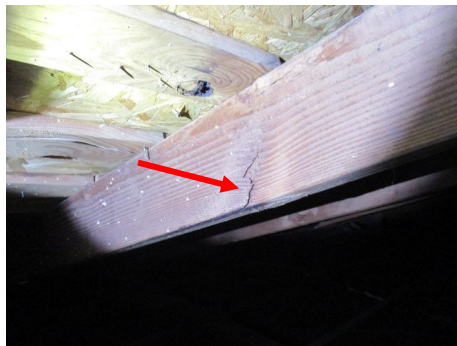
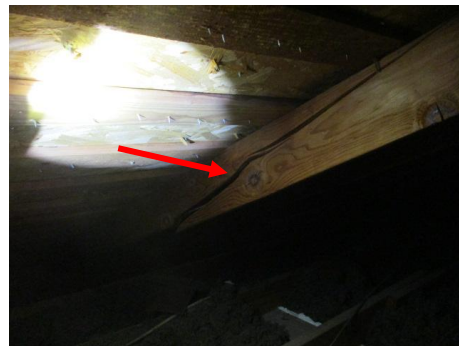
The common and valley rafters of the roof structure show evidence of sagging. Numerous cracked rafters were observed at the south slope and southwest valley. These areas should be investigated further and repaired by a qualified tradesman.

Figure 2 Example of cracked rafter

Figure 3 Example of cracked rafter

Figure 4 Example of cracked rafter

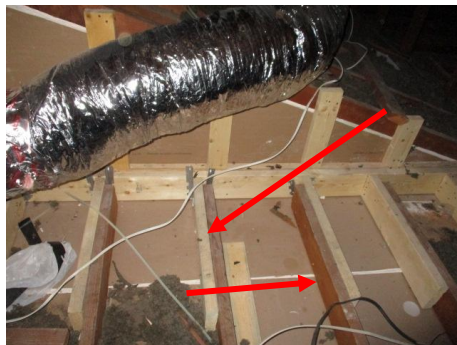
Spliced ceiling joists were observed above the kitchen and should be evaluated and repaired as necessary.

Figure 5 Example of spliced ceiling joists

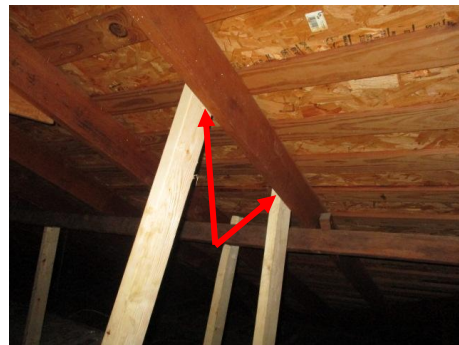
Some rafter supports were observed attached to the sides of the rafters, rather than providing support from below and should be evaluated and repaired if necessary, by a qualified tradesman. Purlin and rafter supports should be braced to a load bearing wall, beam, or girder.

Figure 6 Example of rafter supports attached to side of rafter

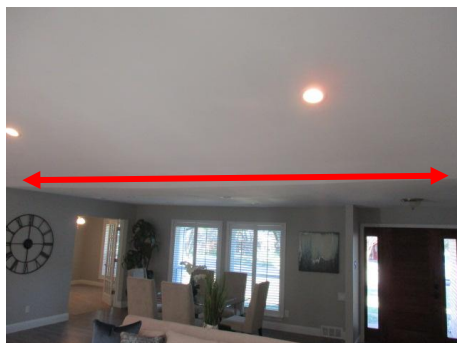
A sagging girder was noted across the span between the living room and dining area. The area should be evaluated and repaired as necessary by a qualified tradesman.

Figure 7 Example of sag in living roof

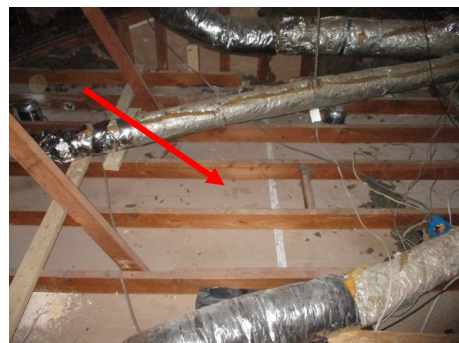
Low and missing insulation levels were noted throughout the attic space. Insulation improvements may be cost effective, depending on the anticipated term of ownership.

Figure 8 Example of missing insulation

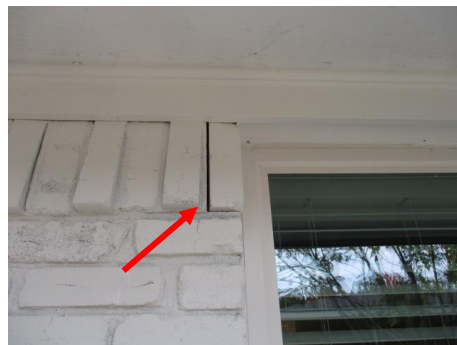
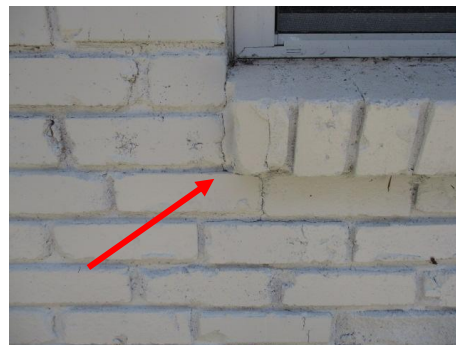
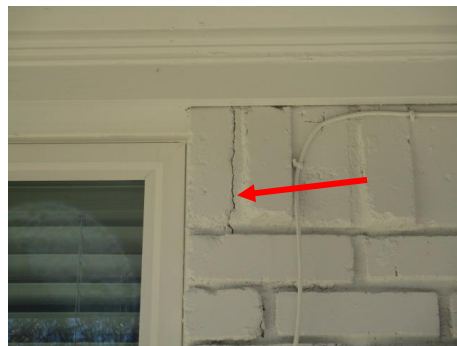
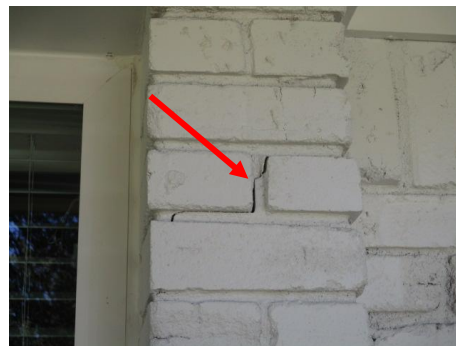
Typical minor cracking was observed at the exterior walls on all sides of the home. This implies that some structural movement of the building has occurred, as is typical of most houses and should be repaired. Minor repointing (replacing mortar between the joints) is needed. (Figures 1-4)

Figure 1 Example of cracking by master bedroom window

Figure 2 Example of cracking by west guest bedroom window

Figure 3 Example of cracking by front entry

Figure 4 Example of cracking at north

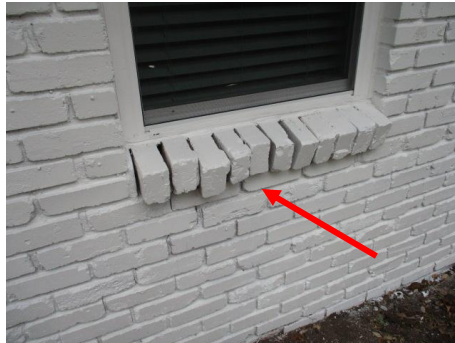
The master bedroom window ledge was noted missing mortar and in general disrepair. This ledge should be rebuilt by a qualified mason. (Figure 5)

Figure 5 Example of missing mortar/damaged master bedroom window ledge

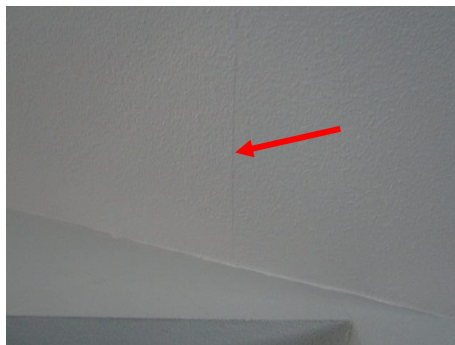
Figure 1 Example of ceiling crack

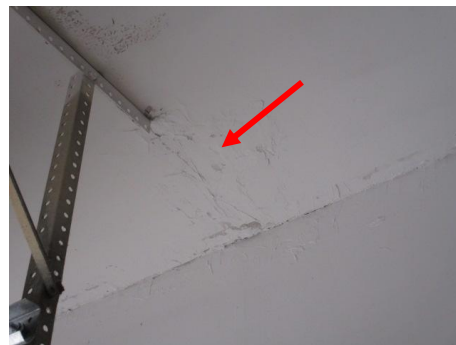
Evidence of patching and repair were noted in the garage. (Figure 2)

Figure 2 Example of patching and repair in garage

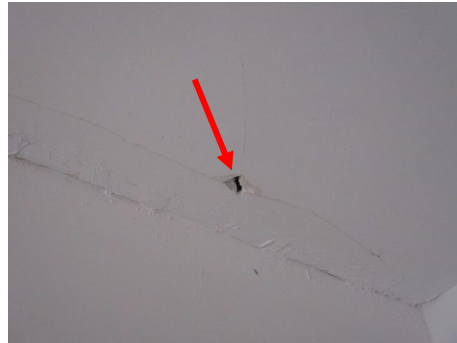
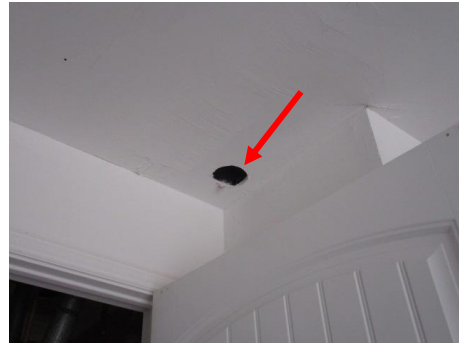
Damage and openings were observed in the garage and should be repaired. (Figures 3-4)

Figure 3 Example of damage at garage ceiling

Figure 4 Example of opening at garage ceiling

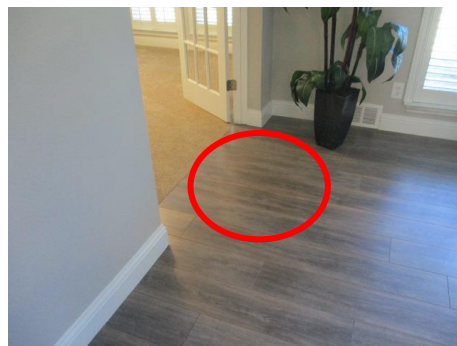
Weak and springy flooring was noted adjacent to the study. This is usually a result of improperly secured subflooring and should be investigated further and repaired. (Figure 1)

Figure 1 Location of springy flooring by study

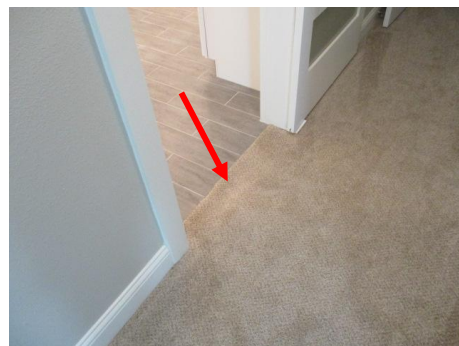
A low area was noted at the entrance to the master bathroom. This may be a result of missing carpet padding or unsecured flooring and should be evaluated further and repaired as necessary. (Figure 2)

Figure 2 Example of low area by master bathroom

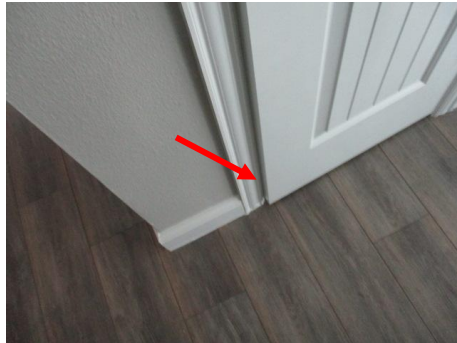
Doors were observed rubbing the frames for the front guest bedroom, front entry, and pantry. The doors and/or hardware should be adjusted to prevent possible damage.

Figure 1 Example of pantry door rubbing frame

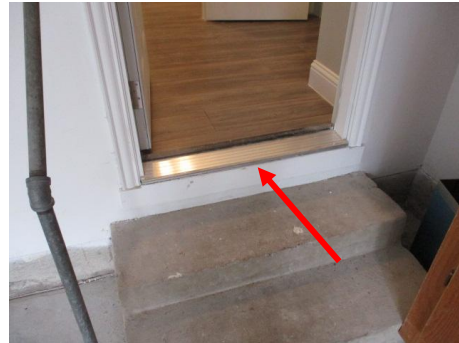
The threshold for the garage entry door was observed as loose and lacking support and should be repaired to prevent possible damage.

Figure 2 Example of garage entry threshold loose/lacking support

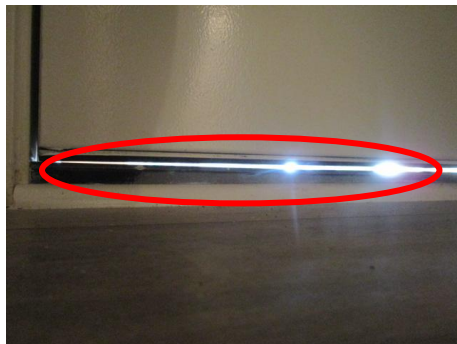
There is air/light infiltrating around the bottom of the garage entry door. The threshold should be adjusted as necessary and/or improvements are needed to the weather stripping.

Figure 3 Example of air/light below garage entry door

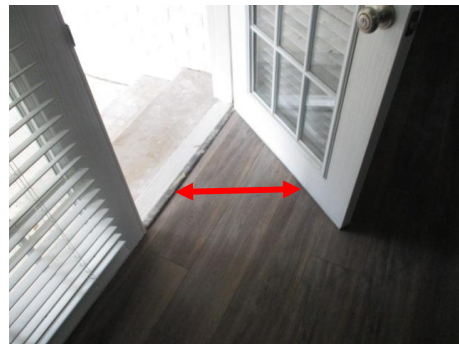
The rear exterior door was observed dragging the threshold and flooring. The door and/or hardware should be adjusted to prevent possible damage.

Figure 4 Example of rear exterior door dragging threshold and floor

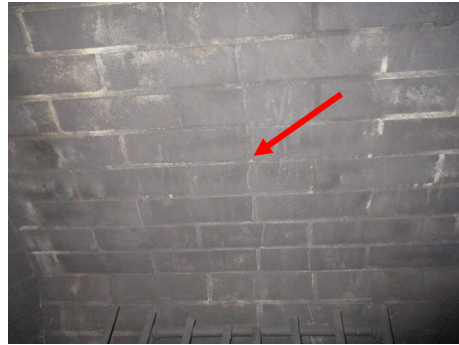
Cracking was noted at the rear of the firebox and should be repaired.

Figure 1 Example of cracking at rear of firebox

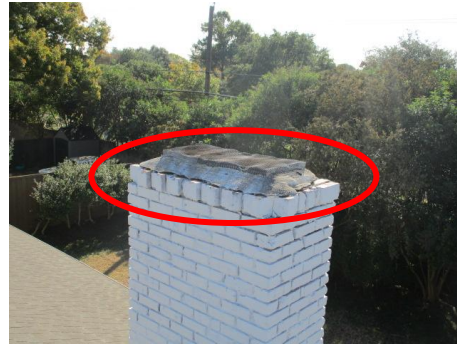
Figure 2 Example of missing rain cap

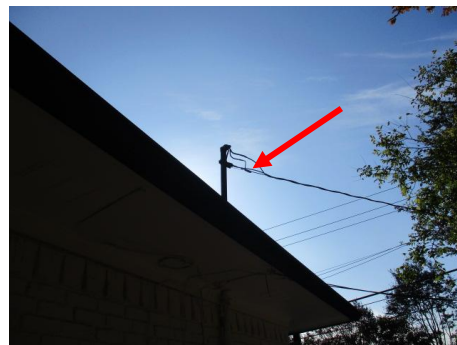
The service wires should form a "drip loop" where they meet the service mast on the exterior of the home. This should be repaired to ensure that water will drip off the wires, rather than run into the service mast. (Figure 2)

Figure 2 Example of insufficient drip loop

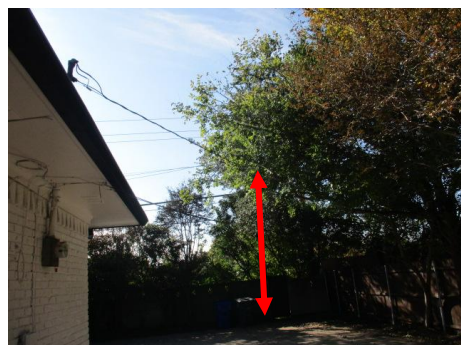
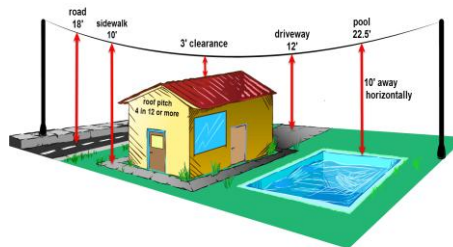
The service wires do not have adequate clearance from the ground and/or trees and should be repaired. The top of the service mast and the service wires should be at least fifteen (15) feet from the ground. (Figures 3-4)

Figure 3 Example of insufficient clearance of service wires

Figure 4 Diagram of proper service wire clearances

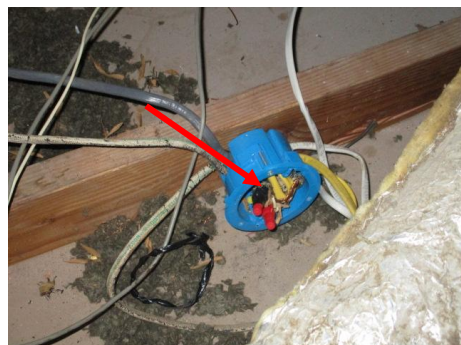
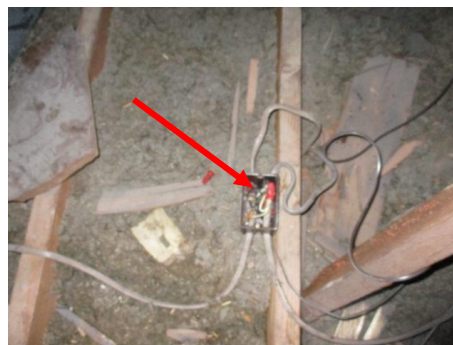
Multiple open junction boxes were noted in the upper attic. This may indicate splices between older and newer wiring in various locations, possibly resulting in overloaded circuits. The electrical system should be evaluated further and repaired as necessary by a licensed electrician.

Figure 1 Example of open junction box in attic

Figure 2 Example of open junction box in attic

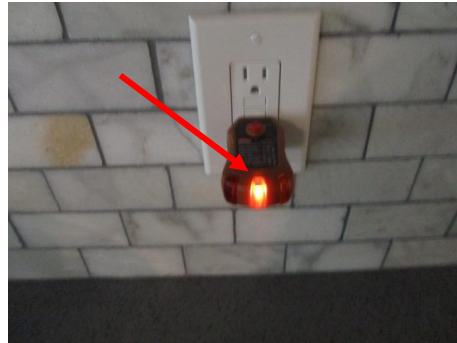
Ungrounded 3-prong outlets were noted in various locations throughout the home and should be improved. This can be as simple as filling the ground slot with epoxy. Alternatively, a grounded cable could be strung to this outlet, or a separate ground wire could be connected. Some electrical codes allow the installation of a ground fault circuit interrupter (GFCI) type outlet where grounding is not provided.

Figure 3 Example of open ground at kitchen outlet

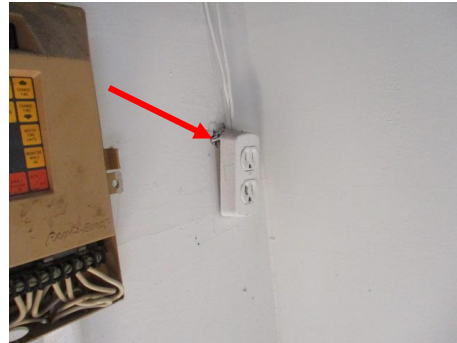
Loose outlets were noted in the garage and should be better secured. (Figure 4)

Figure 4 Example of loose outlet in garage

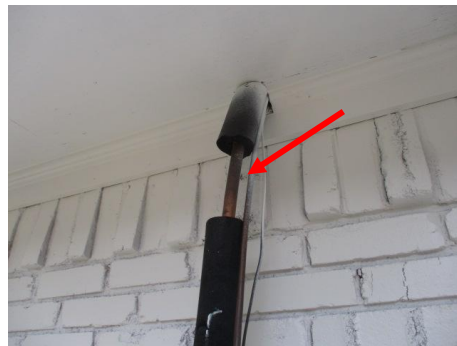
Missing insulation was noted on refrigerant lines for the outside a/c unit and should be repaired to prevent possible damage.

Figure 1 Example of missing insulation at a/c refrigerant lines

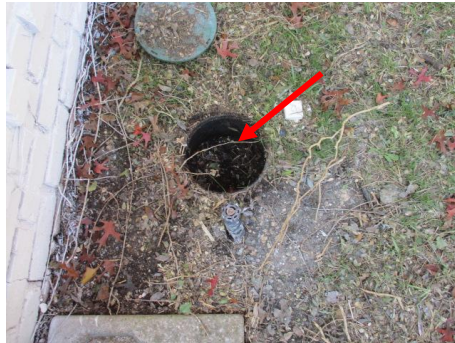
Figure 1 Example of buried water main shut off valve

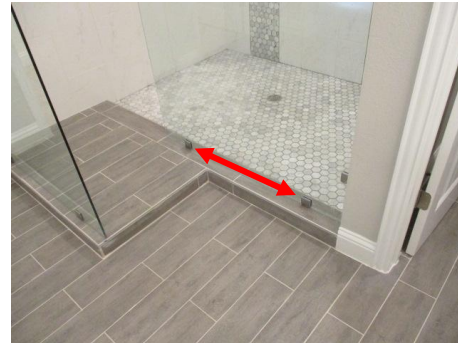
The master shower enclosure leaks at the floor brackets and should be sealed to prevent possible damage.

Figure 2 Example of leak at master shower enclosure

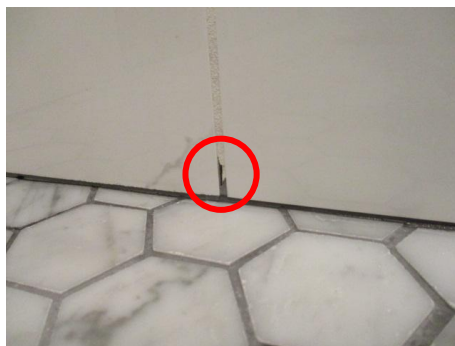
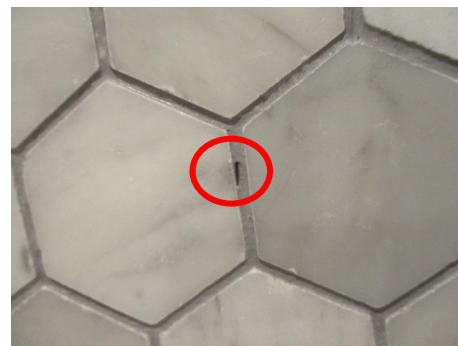
Missing tile grout and caulk was noted for the master bathroom shower enclosure. Tile grout and sealant should be newly applied to prevent possible damage from moisture or water penetration.

Figure 3 Example of missing tile grout/caulk at master shower enclosure

Figure 4 Example of missing tile grout/caulk at master shower enclosure

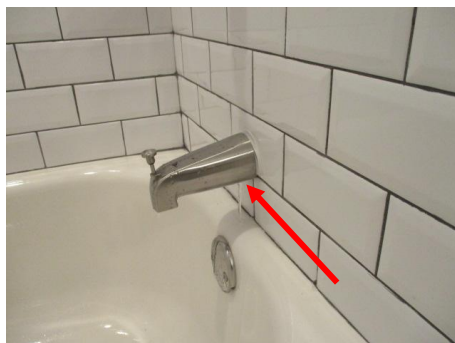
A leak was observed at the guest bathtub spout and should be repaired to prevent water penetration into the wall space. (Figure 5)

Figure 5 Example of leak at guest bathtub spout

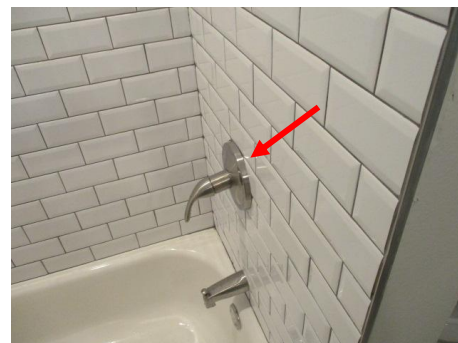
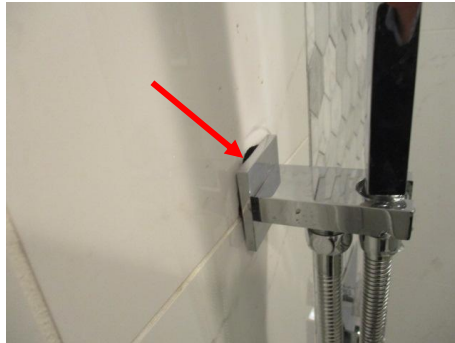
The guest bathroom shower handle and master bathroom handheld shower head should be sealed at the tile to prevent possible future damage from moisture or water penetration. (Figures 6-7)

Figure 6 Example of loose handle for guest bathtub

Figure 7 Example of missing sealant at master shower handheld bracket

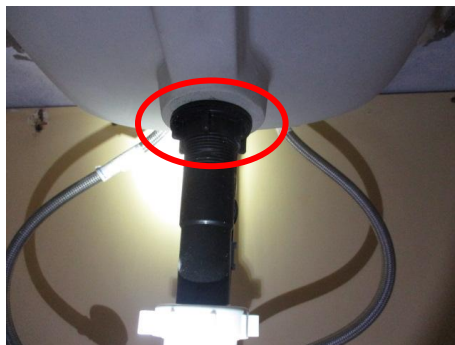
A leak was noted at the left guest bathroom vanity sink drain piping connection and should be repaired to prevent possible damage. (Figure 1)

Figure 1 Location of leak at guest bathroom vanity sink

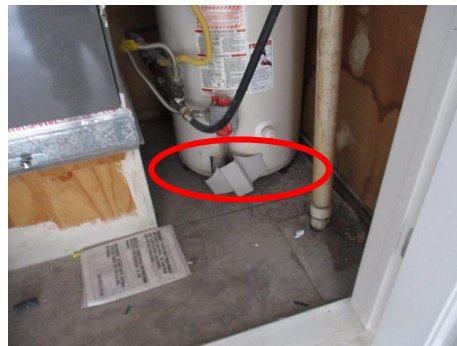
No safety pan and drain were found for the water heater. This should be repaired by the installation of a pan with a drain by a qualified professional.

Figure 1 Example of missing drain pan/piping

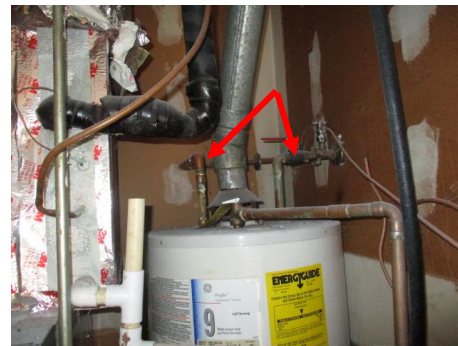
Missing insulation was noted at the water heater supply piping and should be installed to prevent possible damage during the colder months.

Figure 2 Example of missing insulation at water supply piping

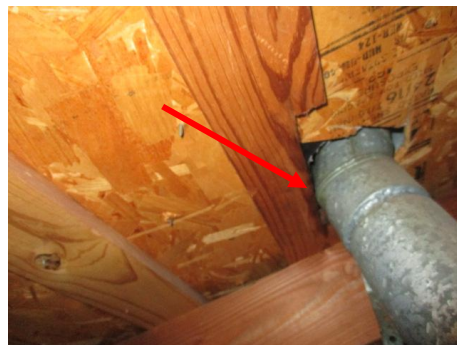
The vent pipe serving the water heater does not have safe clearance from combustible materials. *This condition should be improved for safety reasons.* (Figure 3)

Figure 3 Example of insufficient clearance for vent pipe

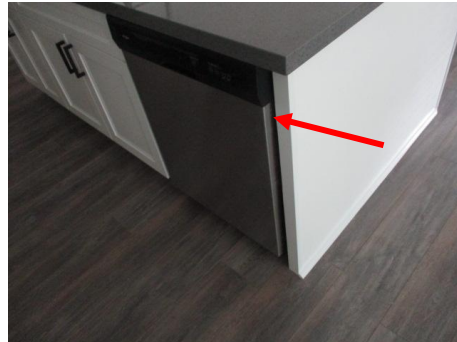
The dishwasher is not properly mounted and should be better secured. (Figure 1)

Figure 1 Example of dishwasher not properly mounted

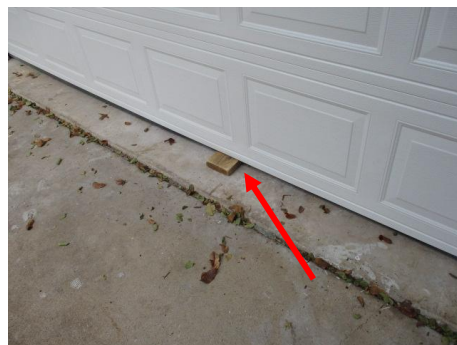
The overhead garage door opener did not automatically reverse under resistance to closing. There is a serious risk of injury, particularly to children, under this condition. Improvement may be as simple as adjusting the sensitivity control on the opener. This should be repaired immediately. (Figure 1)

Figure 1 Example of garage door not reversing under resistance

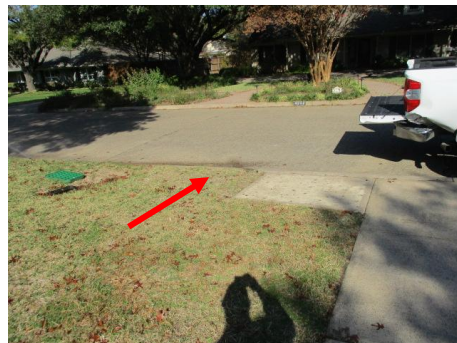
Zone 4: A low pressure head was noted by the curb and should be evaluated for repair as this may indicate a possible leak.

Figure 1 Example of low-pressure head in Front Yard Zone 4

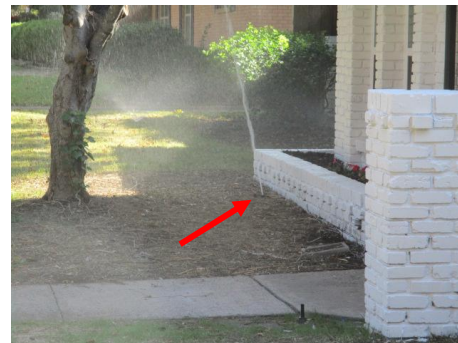
Zone 7: A damaged sprinkler head was noted by the front yard tree and should be repaired.

Figure 2 Example of damaged sprinkler head in Front Yard Zone 7

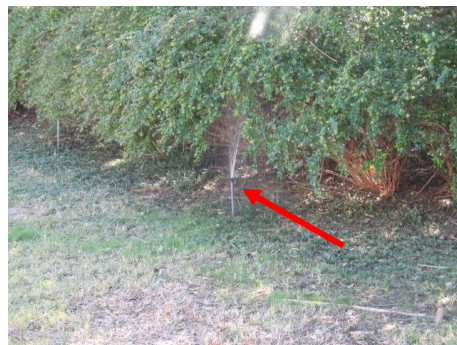
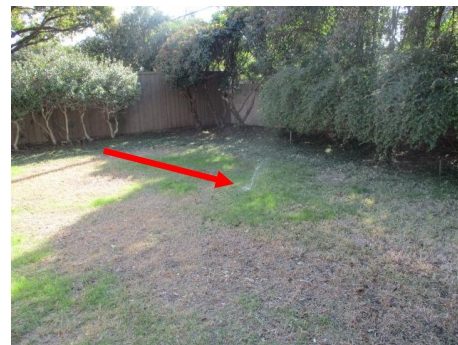
Zones 1 and 3: Damaged sprinkler heads were noted in the back yard and should be repaired or replaced. (Figures 3-4)

Figure 3 Example of damaged sprinkler head in Back Yard Zone 1

Figure 4 Example of damaged sprinkler head in Back Yard Zone 3
